Technical Memorandum 8-60

HUMAN FACTORS ENGINEERING EVALUATION
OF THE
M60 MAIN BATTLE TANK

Kermit D. Foster

June 1960

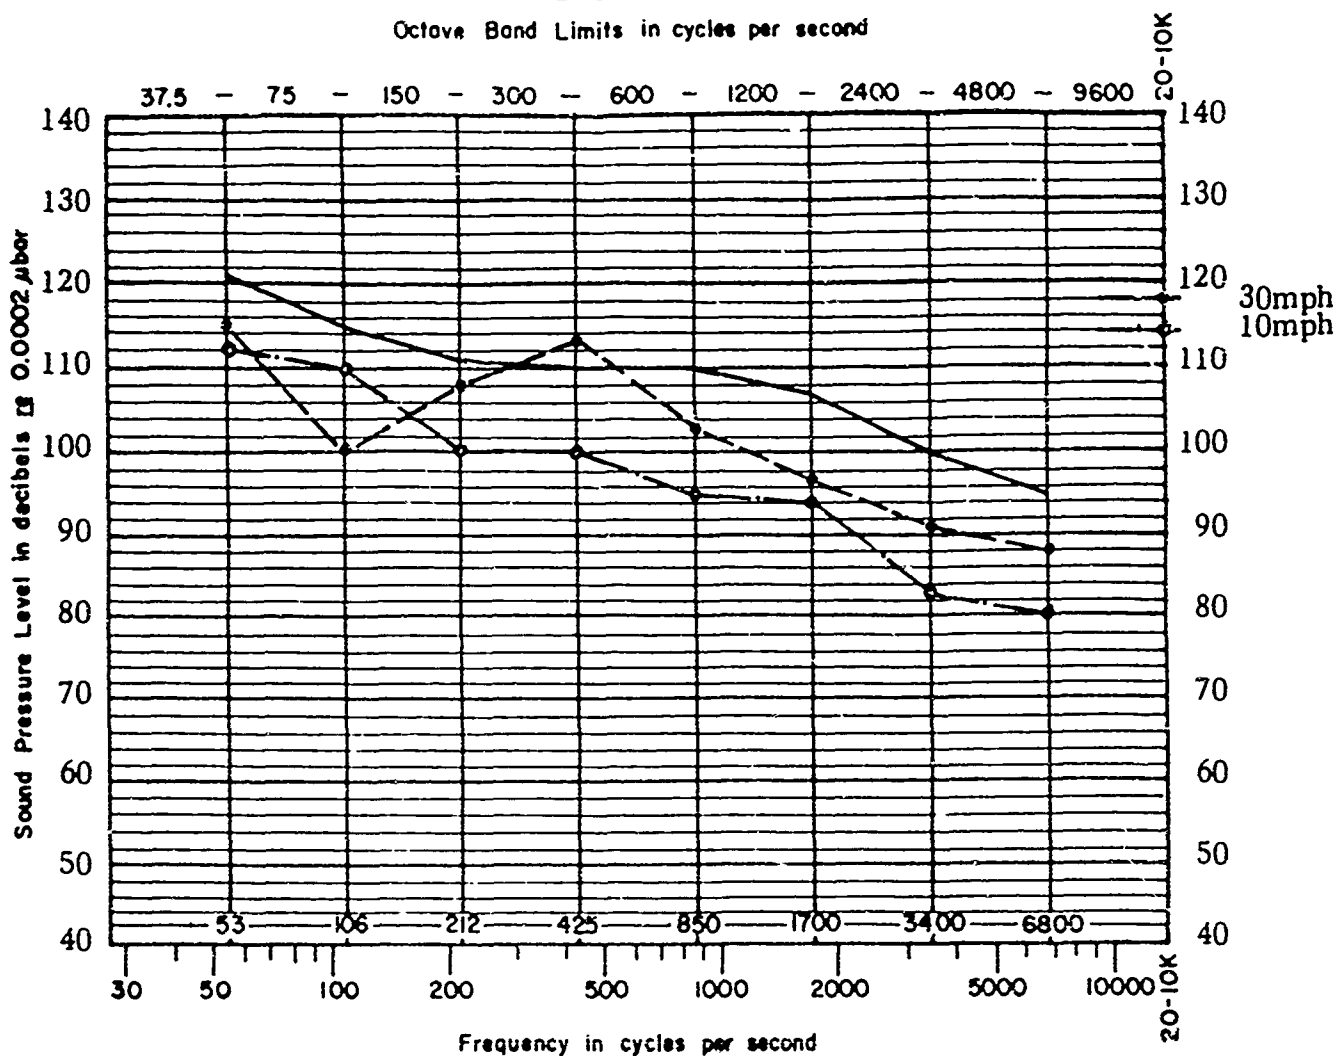
Fig. 1. Octave band measurements of the noise in the turret of the M60 Tank at 30 mph and 10 mph

An octave band analysis of noise in the turret at speeds of 30 mph (high range) and 10 mph (low range) was also conducted. At 500 cycles per second, the sound pressure level exceeds the Human Engineering Laboratories' maximum sound pressure level standard for that octave band by 3 db. This deviation from the recommended limit is negligible and no action, in terms of additional sound attenuation, is recommended.
